SEPTIC SYSTEM INSPECTION REPORT

For
Journey Homes

555 Totts Gap Road, Bangor, PA 18013

February 13, 2023

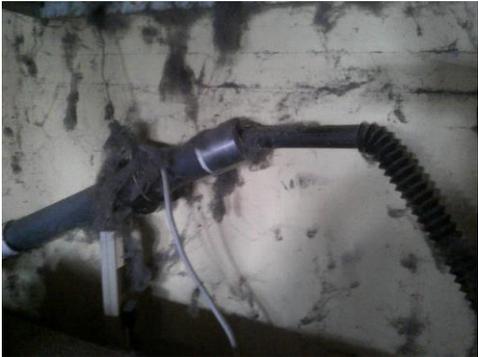
Washer Pipe

The grey water from the washing machine is not connected to the onlot wastewater system. Based on these findings a Hydraulic Load Test is necessary to complete a PSMA inspection.

Corrective Measures: Machine dig to locate the distribution box for the purpose of running a camera to determine the cause of uneven distribution to the trenches. Have a licensed plumber connect the washing machine to the Onlot System. A hydraulic load test is then necessary to complete a PSMA inspection.

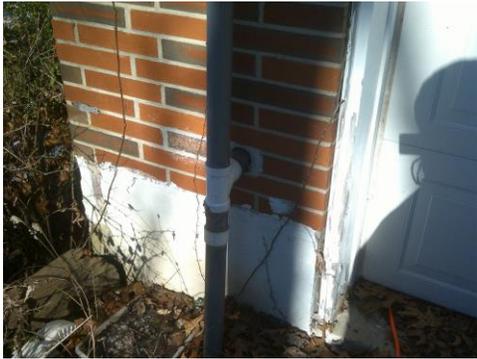
Washer pipe -discharge onto lawn

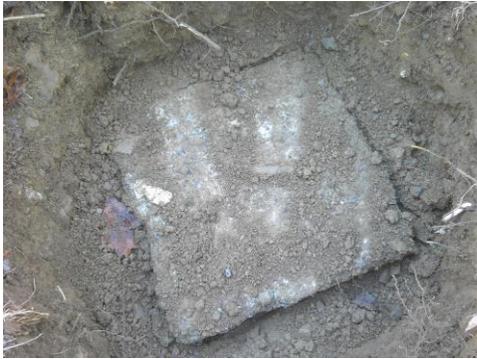
Septic Tank Lid

1. A 1000-gallon one compartment concrete septic tank was found. No pumping was performed at the time of the inspection. Based on this information the septic tank was found to **need more investigation**.

After the hydraulic load test was completed, 1000 gallons was pumped from the septic tank. Based on this information the septic tank was now found to be in **satisfactory condition**.

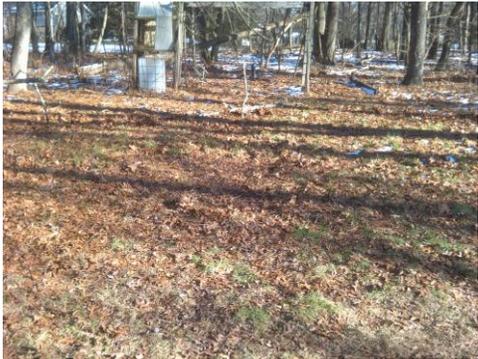
Field

2. The absorption area consists of three trenches approximately 3' x 40'. Trench One and Two were probed, they were found to have 12" of dry aggregate. Trench three was probed and found to have 4" of dry aggregate. No evidence of surface leachate or lush vegetation. Based on this information the absorption area was found to **need more investigation**.

The absorption area consists of three trenches approximately 3' x 40'. On both days of the hydraulic load test before introducing the water the absorption area was probed and found to contain 0" of liquid in the aggregate as measured from the bottom of the 12" of aggregate and after introducing the water the absorption area was probed and found to contain 3" of liquid in the aggregate as measured from the bottom of the aggregate. Found no evidence of surface leachate, or lush vegetation. Based on this information the absorption area was now found to be in **satisfactory condition**.

Addendum: On January 18, 2023, Allstate Septic Systems returned to the property machine-dug down to pipe, ran camera and located the d-box. The d-box was in good condition, installed a speed leveler on one pipe and installed a port to run hydraulic load test.
